**NATIONAL TESTING AND CONSULTING, L.L.C.**

December 3, 2014

Re: Sauter vs. Perfect North Slopes

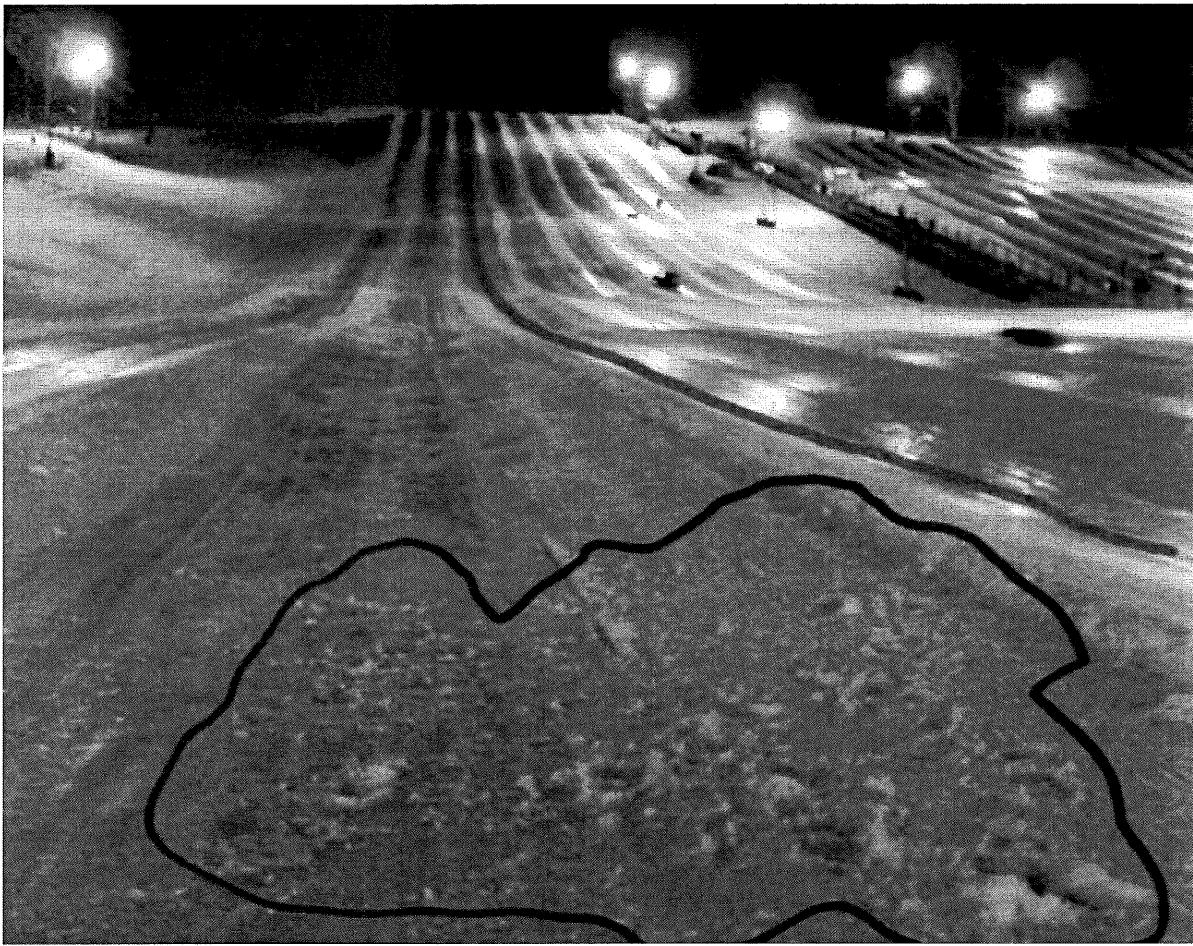
Figure 2 – View looking uphill at the base of Lane 8. Lane 7 has a black line drawn up it. The footprints encircled with black marker in the foreground are reportedly associated with M [REDACTED] S [REDACTED]’s point of rest.
